The Pump Detective

The case of the poorly performing (piped) pump:

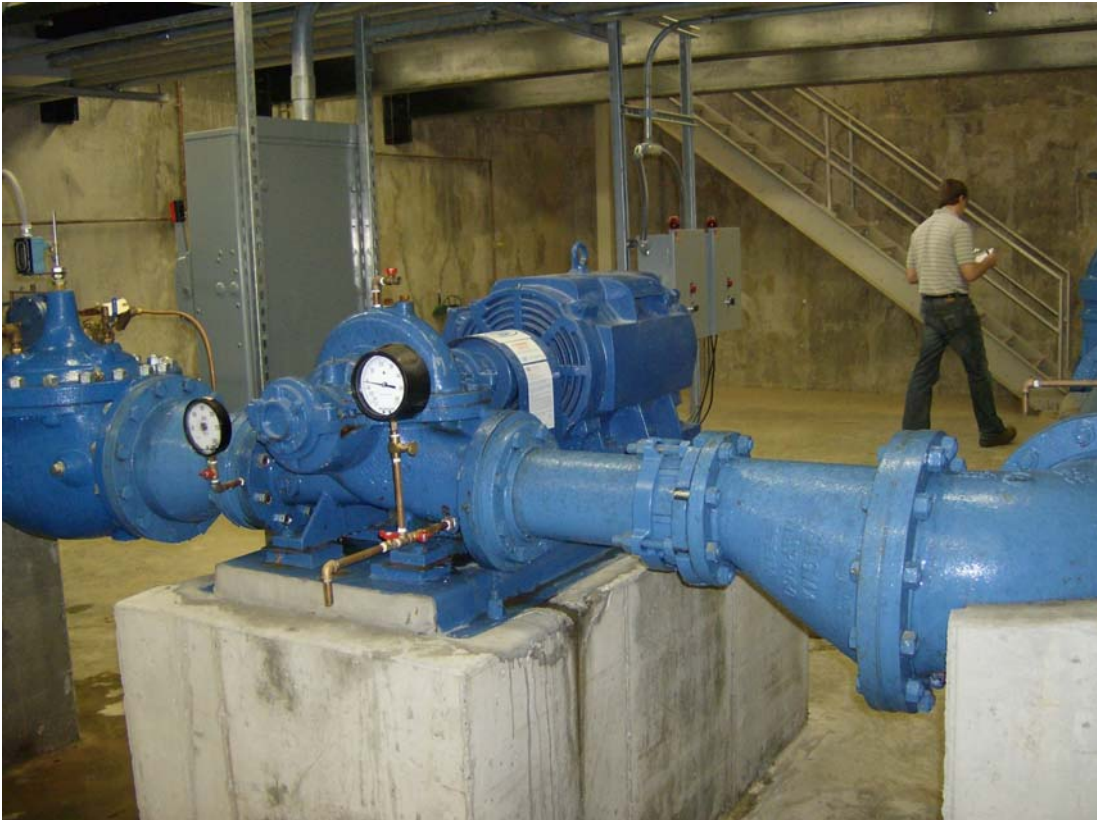
As the right edge of the picture shows, the pump's suction piping had a horizontal elbow immediately before the pump.

Horizontal elbows on pump suction, ESPECIALLY double suction pumps, are not recommended. This is poor piping practice and not in accordance with HI guidelines. The sketch shows how the liquid is distributed unevenly to the two impeller eyes.

The out board end gets more flow due to the centrifugal force pushing the water to that side and the inboard side gets less flow. This creates flow instability and sometimes cavitation. Besides affecting performance, it will cause uneven pressure distribution and nullify the axial thrust balance of a double suction impeller. This will cause premature bearing failure due to excessive axial thrust.

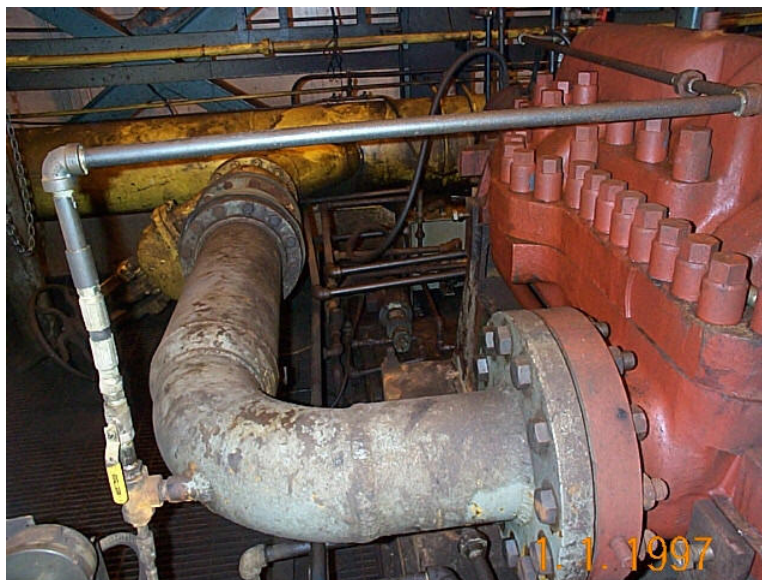
This is not uncommon as seen by the second picture of a 2500 HP multistage pump with a double suction impeller and horizontal elbow, dooming it to very low reliability. But that is for future "Pump Detective"
