The Pump Detective

By Doug Kriebel, PE

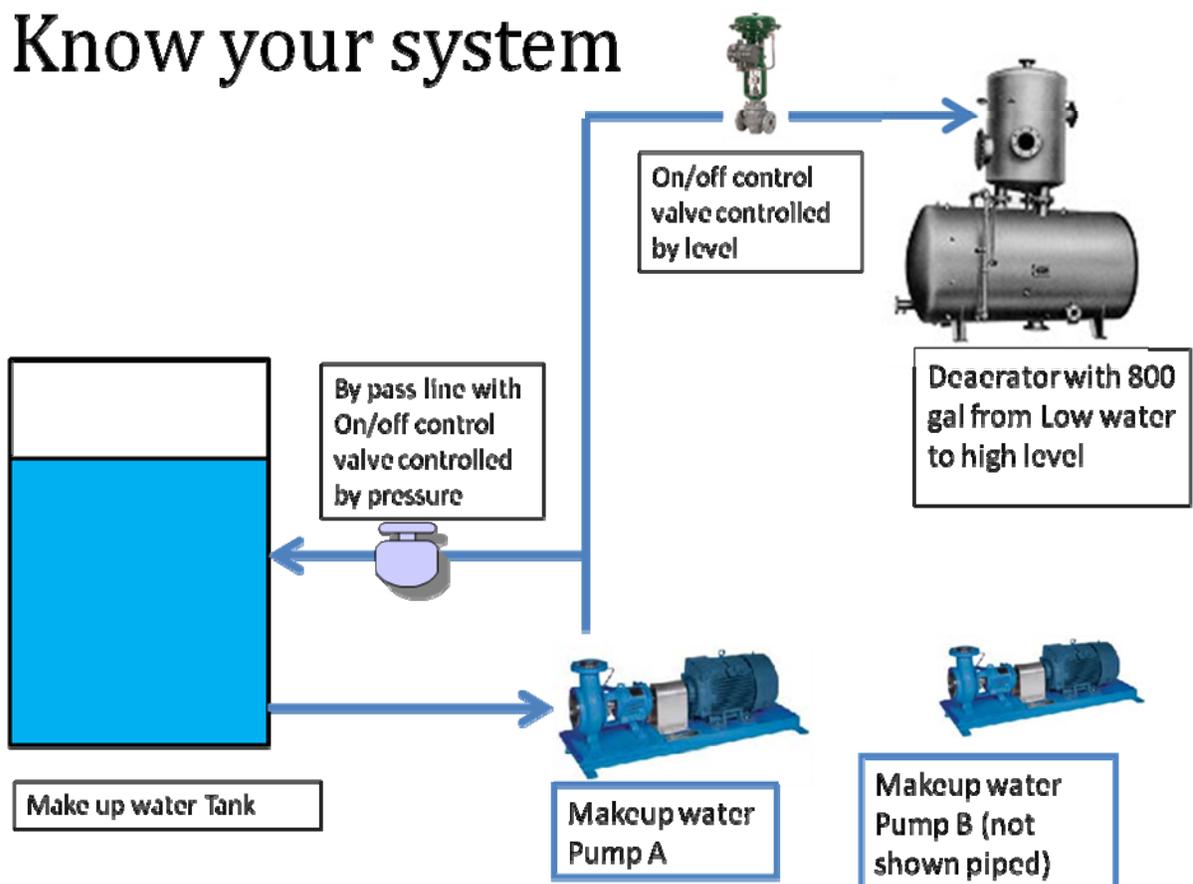
Investigation found a bypass line under insulation, which no one knew existed.

It had a bypass pipe line from the pump discharge back to the suction line. There was a pressure sensing valve which opened when the pressure rose due to the makeup valve being closed, and opened when the makeup valve opened.

Further investigation revealed the "A" pressure valve had failed, not allowing sufficient flow to protect the pump. It had only happened on one pump. The "B" valve was ok. So, there were no failures on the "B" pump.

The recirculation valves were replaced on both pumps and the system has performed well ever since.
