The Pump Detective

By Doug Kriebel

The "Replacement"

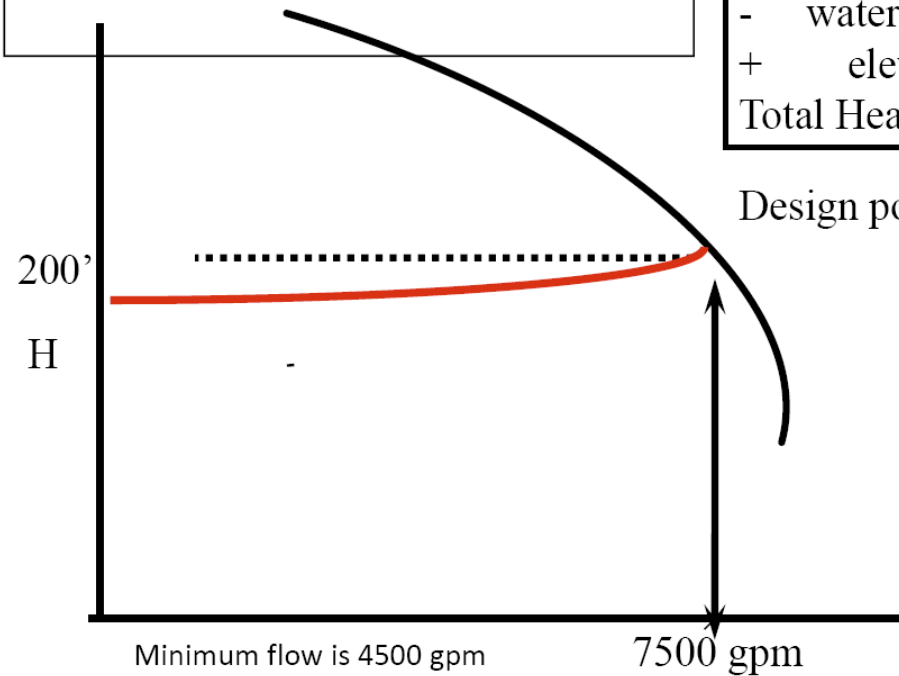
System Head Curve and Pump Curve

The nameplate hydraulics were 7500 gpm at 200'. They wanted 75 psig at the discharge, the pit depth is 31', and there is 4' of water level above the pump suction. This all checked if you look at the Sketch and calculations on the performance curve.

$75 \text{ psig} \times 2.31 / 1.0 = 173'$	
-	water level - 4'
+	elevation + 31'
Total Head = 200'

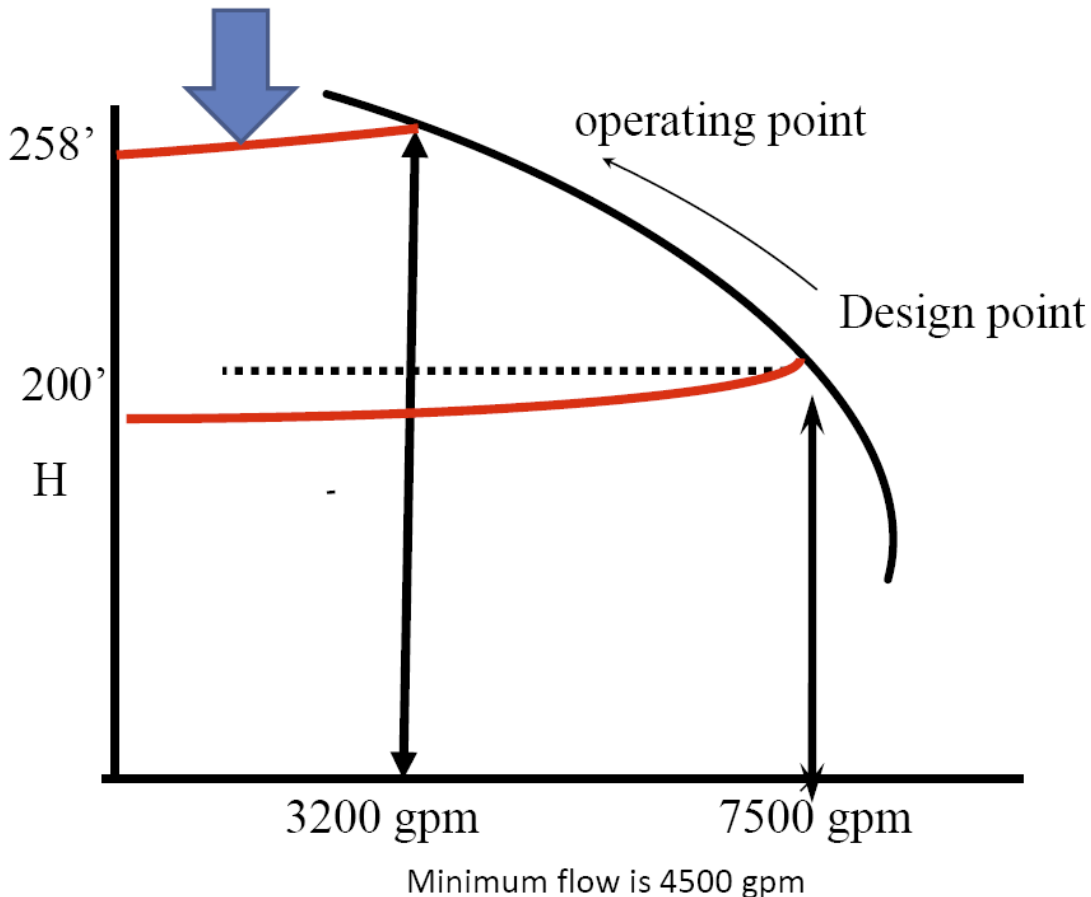
- System Head Curve for new system conditions.

As you can see from the picture, the pump is running at 100 psig discharge pressure which is a head of 258', which means the pumps are operating at 3200 gpm which is below the pump's minimum flow of 4500 gpm. This was the reason for the failure of these pumps, and also the "poorly performing" original pumps.

It turns out that over the years the plant had scaled back and instead of running cooling water to two loops; it was only needed for one loop. Trying to put all that water through a smaller piping system created additional head which forced the pumps back on the curve.

The quick fix is to bypass 1300 gpm through a minimum flow by pass line back to the river to bring the pump's operation to the minimum flow.

The better fix is to calculate the needed flow and head for the current conditions and specify these for a new, smaller pump. Or if conditions are right, use a VFD to tune the existing pumps to the system.
